# Moel y Gaer Llanbedr Dyffryn Clwyd

Excavations, Summer 2009

Preliminary Report

**Raimund Karl and Hazel Butler**

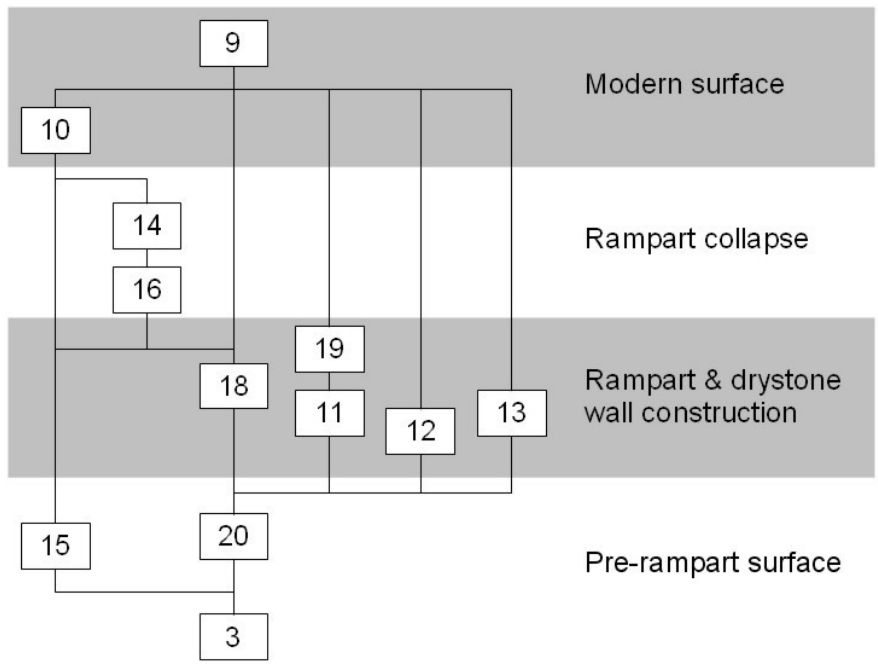
Fig. 4: Stratigraphic sequence of trench 1

The stratigraphic sequence in trench 1 (fig. 4) mainly consists of a single phase, stone fronted (CN 18) rampart built, in the area excavated, mostly from highly burnt (CN 11) and partially vitrified (CN 19) mixed and broken fragments of shale, partially stuck together by flow slag, with the stones very similar to the local bedrock. The rampart partly sits on a layer of burnt old turf (CN 20), which in turn sits partially on natural bedrock (CN3), in part on a thin layer of brownish-yellow subsoil (CN 15) on top of the natural bedrock. However, the natural bedrock (CN 3) and the layer of subsoil which lies over it in parts of trench 1 (CN 15) interestingly shows no evidence of having been subject to heat, either underneath or outside the rampart (fig. 5). The rampart stone fronting collapsed in parts of the section (CN16), with various layers of intermixed material (CN 10, 14) on top of it.

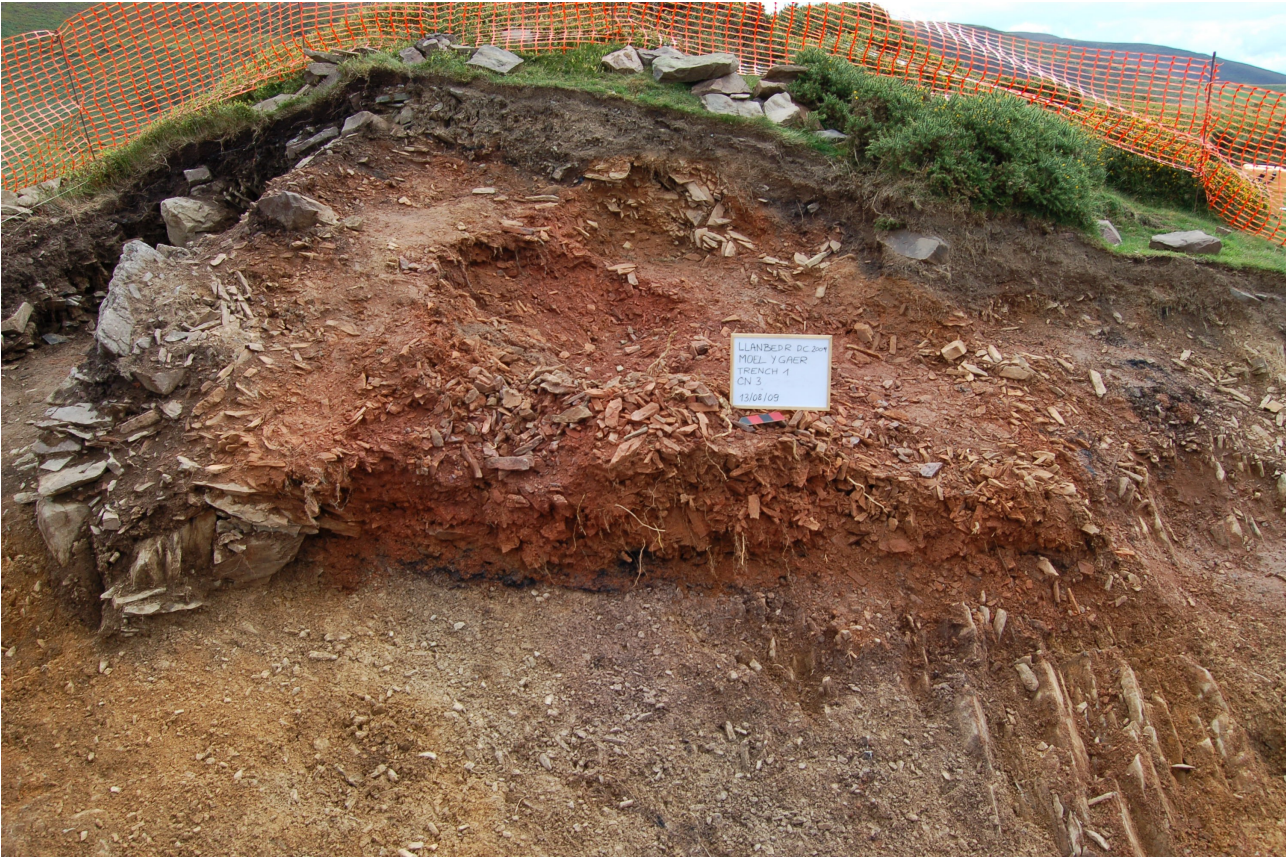
Fig. 5: The rampart in section, with the subsoil layer (CN 15) and bedrock (CN 3) exposed in the foreground, clearly showing no exposure to heat as compared with the rampart body (CN 11) itself. The stone facing of the rampart (CN 18) is to the left of the rampart body.

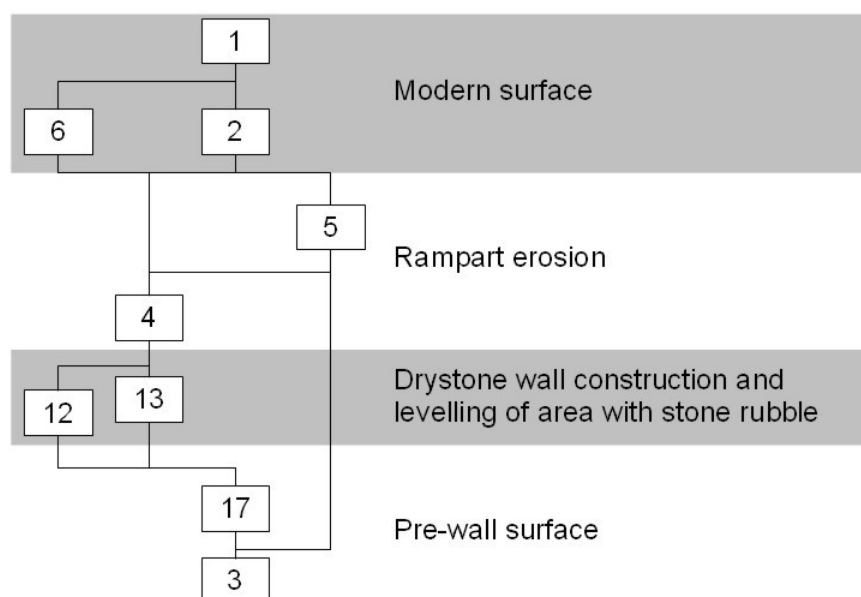
Fig. 6: Stratigraphic sequence of trench 2

The stratigraphic sequence in trench 2 (fig. 6) mainly consists of a drystone wall / foundation (CN 12; fig. 7) also observed in the south-western corner of trench 1, and a layer of broken stone (CN 13) to the north-west of it, possibly a levelling layer, also observed in trench 1. Both sit more or less directly on a layer of decomposed / burnt old turf with substantial amounts of charcoal in it (CN 17), which in turn rests on the natural bedrock (CN 3). On top of these two features (CN 12, 13) is a layer of orange-brownish material which seems to have eroded down from the rampart (CN 4), which is partially overlain by a lense of eroded natural bedrock from the outcropping directly to the east of trench 2 (CN 5), and, in the south-western corner of trench 2, a modern fireplace (CN 6) surrounded by large stones of the kind used to make up the rampart facing in trench 1 (CN 18) and the drystone wall / foundation (CN 12). Much of the stratigraphy in trench 2 is overlain by a thin layer of silty, yellow-orangy sand (CN 2), probably material washed down from the rampart (CN 11) in trench 1 and intermixed with subsoil / turf. The whole stratification of trench 2 is overlain by a c. 5-15 cm strong layer of turf.

Rather, as is clearly evident from the sharp boundary between the natural and the burnt material that makes up the rampart body (see fig. 6 above), that the burnt and vitrified material was dumped on site to construct the rampart body after having been exposed to intensive heat elsewhere. Since the vitrified material seems to mostly consist of light, bubbly flow slag, possibly from iron smelting, we suggest that the material to construct the north-eastern corner of the rampart of *Moel y Gaer* was taken from an iron smelting midden. Since there is no evidence of iron working on the hillfort itself or in its immediate vicinity, nor of a midden with large amounts of burnt and vitrified stone, it has to be assumed that the midden material was brought to the hillfort. This raises some interesting questions.

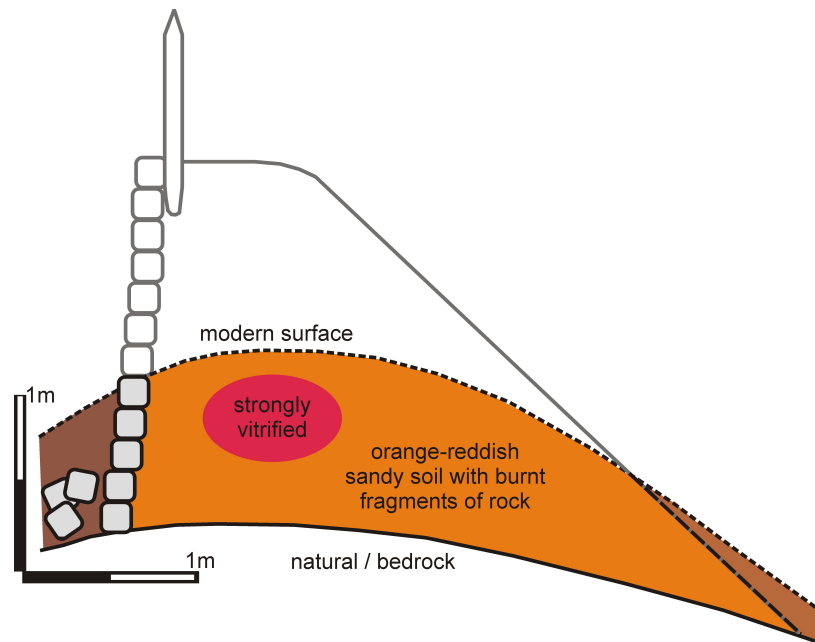
Fig. 9: tentative reconstruction of rampart based on simplified section drawing

The excavation also helped to clarify the construction of the rampart (fig. 9), which seems to be a simple dump rampart with an external stone fronting. The stone fronting leans slightly onto the dump rampart's body, which stabilises the not very sophisticated and not particularly well-built drystone wall that makes up the external facing. It can probably be assumed that the drystone facing would not have lasted much longer than c. 3-5 decades before collapsing. Indeed, during the excavation, rampart collapse pretty much down to its foundation was discovered in parts of trench 1. The dump rampart itself turned out during excavation to consist of relatively loose rubble with a lot of highly burnt stones and vitrified lumps, probably slag from metalworking / smelting which in itself cannot have been very stable either. The rampart itself was approximately 4 meters wide, which allows, in conjunction with the amounts of material which seem to have eroded from the rampart down into the area covered by trench 2, to estimate that the rampart would originally have stood to probably at least 2 meters high, but no more than c. 3 meters high in the area we excavated. However, since the area is on an elevated natural outcropping of bedrock, this may have been a rather lowish section of the rampart, which may have been somewhat higher in other

parts of the hillfort. No evidence was found for any internal construction features in the rampart, or for any palisade or fencing on top of it, but this is hardly surprising since even the best preserved parts of the rampart in trench 1 did not exceed c. 1 meter in height, that is at least 1 meter below its original height. Any feature that may have originally stood on top of the rampart is thus necessarily lost without trace, since not even the strongest palisade would have been set over a meter into the rampart's body.
