**Moel y Gaer
Llanbedr Dyffryn Clwyd
Excavations, Summer 2009
Preliminary Report**

Raimund Karl and Hazel Butler

Bangor/Gwynedd, August 2009

Bangor Studies in Archaeology
Report No. 1

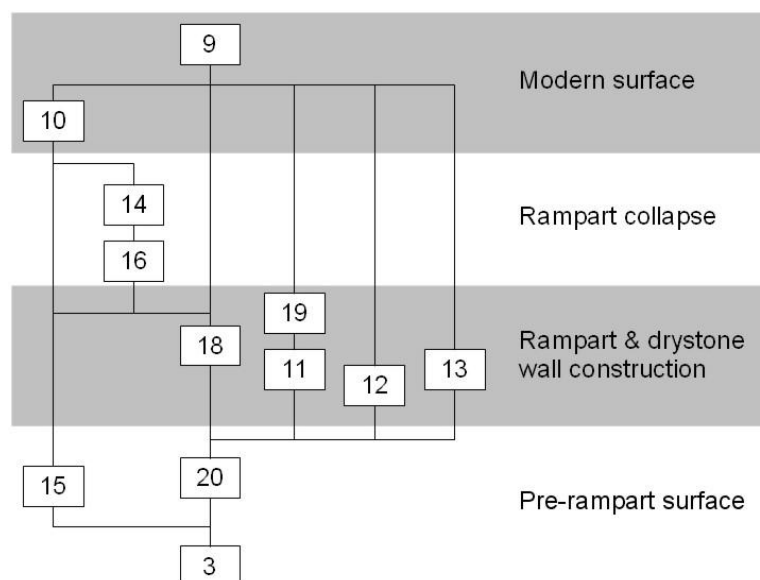
Figure 4: Stratigraphic sequence of trench 1.

The stratigraphic sequence in trench 1 (fig 4) mainly consists of a single phase, stone fronted (CN 18) rampart built, in the area excavated, mostly from highly burnt (CN 11) and partially vitrified (CN 19) mixed broken up fragments of shale, partially stuck together by flow slag, with the stones very similar to the local bedrock. The rampart partly sits on a layer of burnt old turf (CN 20), which in turn sits partially on natural bedrock (CN3), partially on a thin layer of brownish-yellow subsoil (CN 15) on top of the natural bedrock. However, the natural bedrock (CN 3) and the layer of subsoil which lies over it in parts of trench 1 (CN 15) interestingly shows no evidence of having been subject to heat, neither underneath nor outside of the rampart (fig 5). The rampart stone fronting collapsed in parts of the section (CN16), with various layers of intermixed material (CN 10, 14) on top of it.

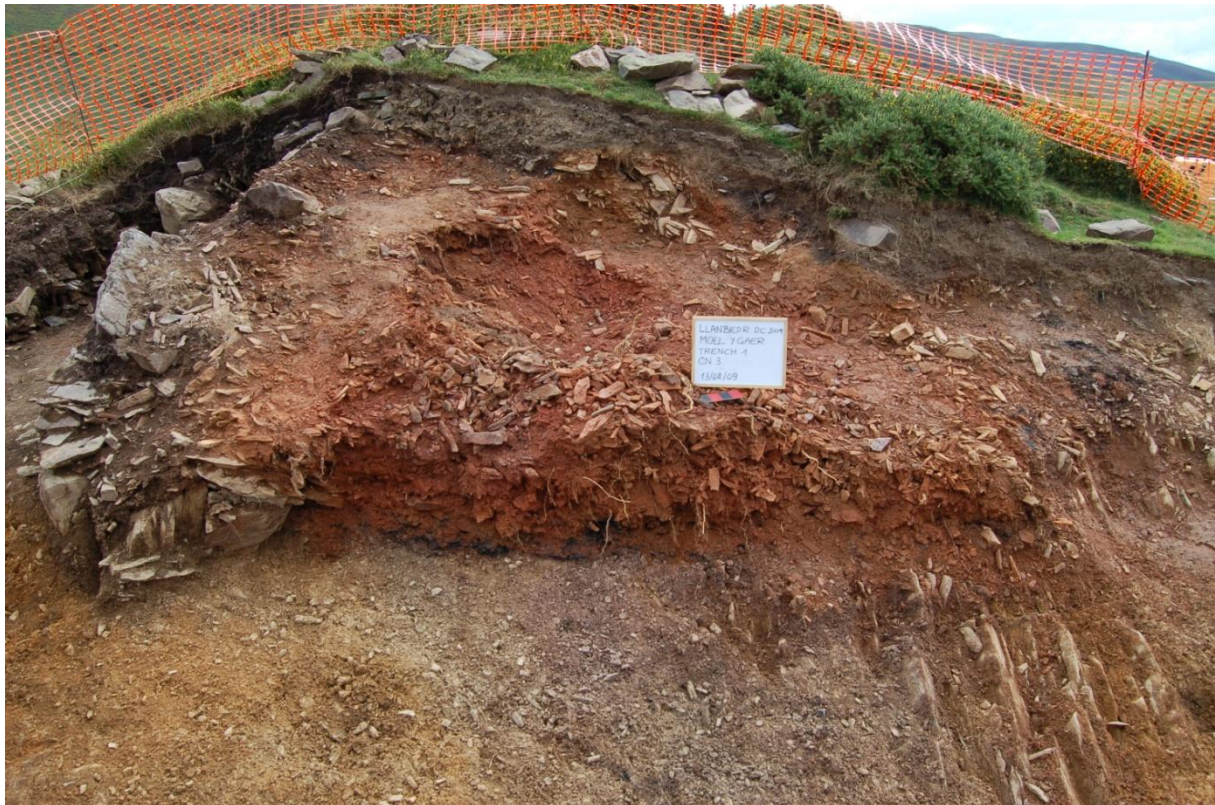
Figure 5: The rampart in section, with the subsoil layer (CN 15) and bedrock (CN 3) exposed in the foreground, clearly showing no exposure to heat as compared with the rampart body (CN 11) itself. The stone facing of the rampart (CN 18) is to the left of the rampart body.

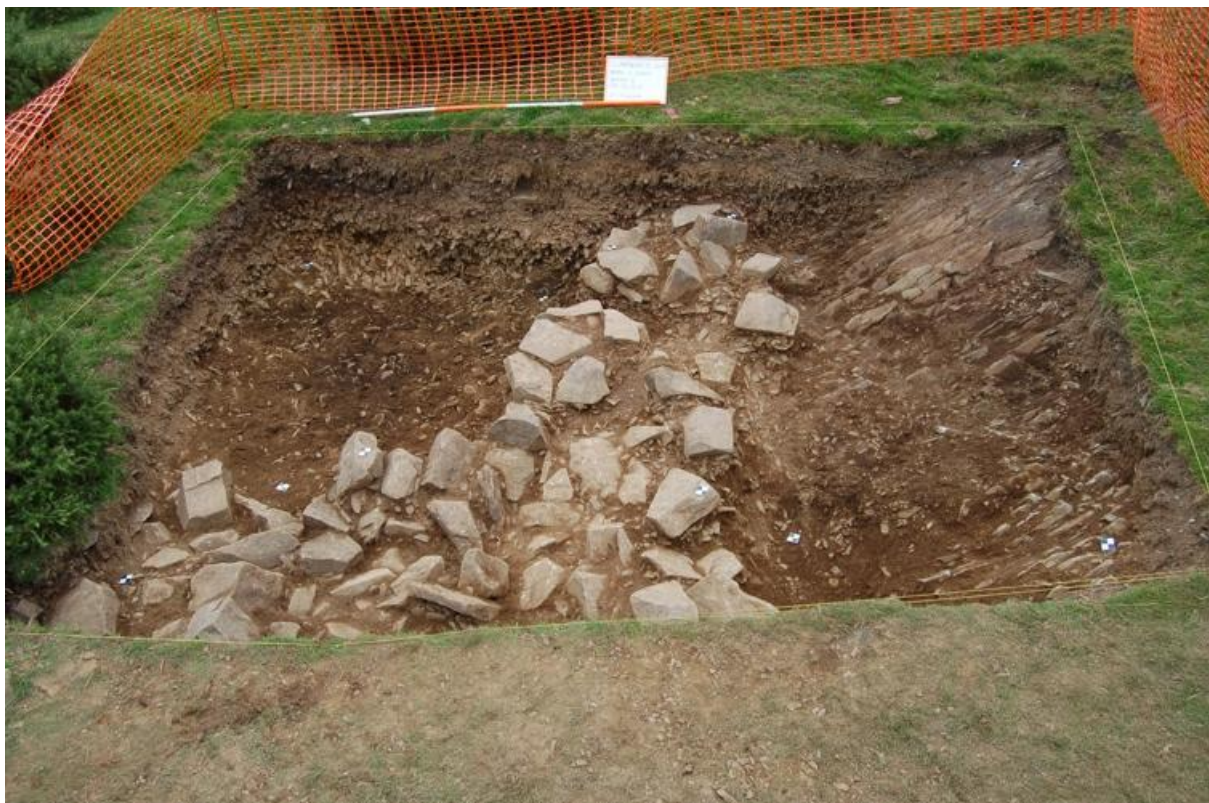
Fig. 7: The drystone wall / foundation (CN 12) exposed in trench 2.

The stratigraphic sequence in trench 2 (fig 6) mainly consists of a drystone wall / foundation (CN 12; fig 7) also observed in the south-western corner of trench 1, and a layer of broken stone (CN 13) to the north-west of it, possibly a levelling layer, also observed in trench 1. Both sit more or less directly on a layer of decomposed / burnt old turf with substantial amounts of charcoal in it (CN 17), which in

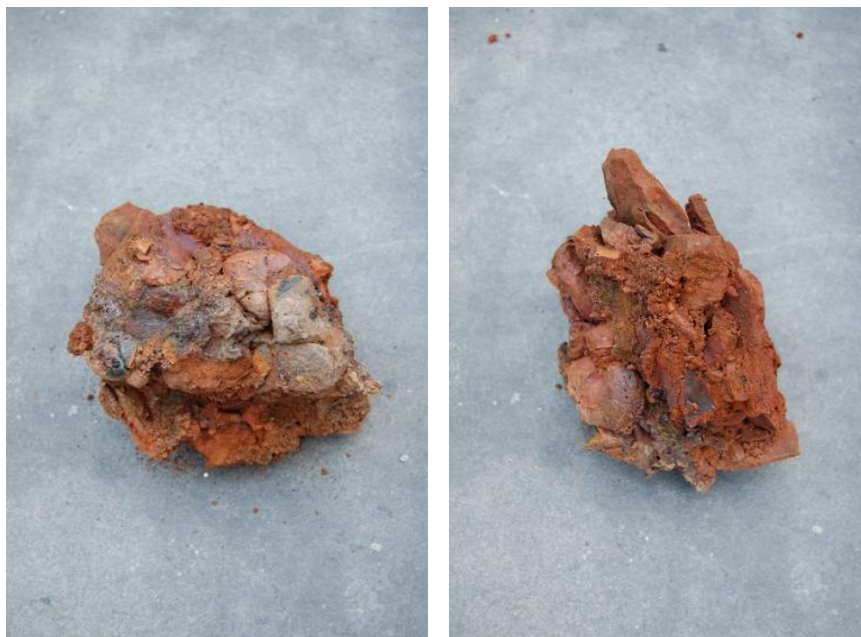
Figure 8: a piece of vitrified material / flow slag, original dimensions c. 15X10x10 cm.

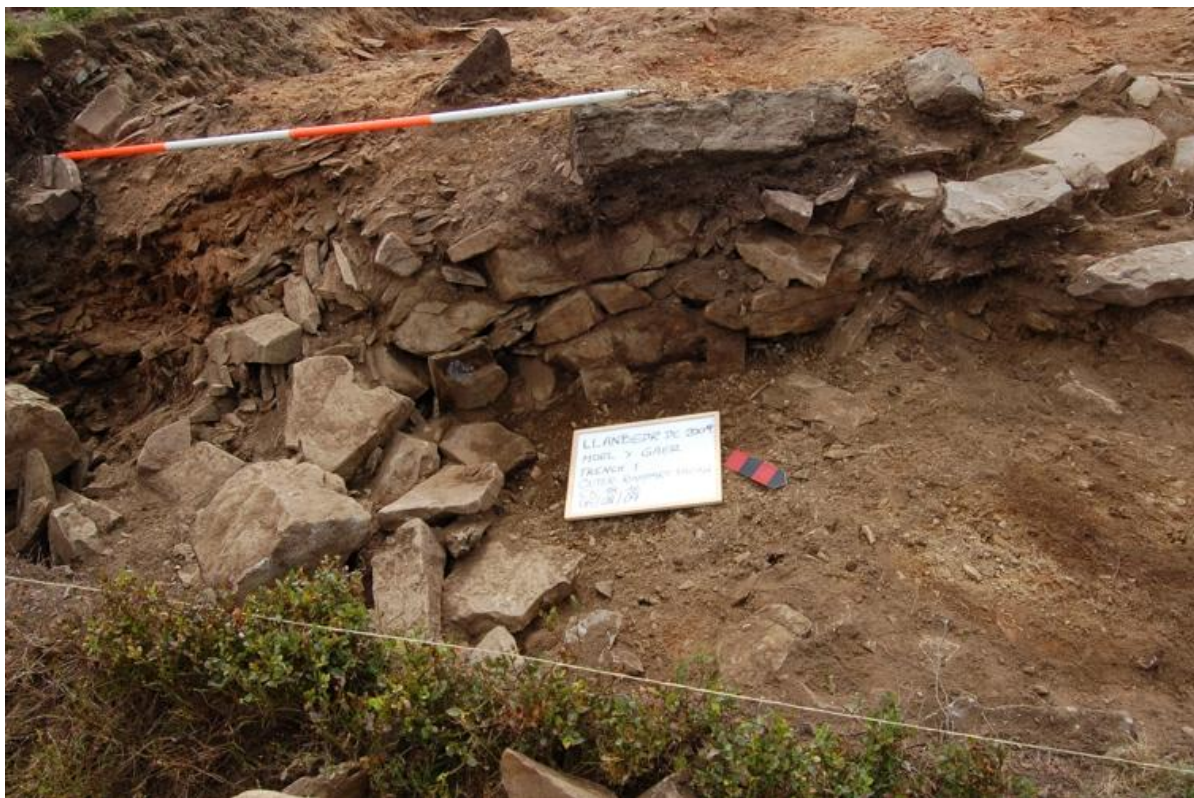
Figure 10: best preserved zone of drystone fronting of the rampart, with rampart collapse to the left.
